Submersible Axial Flow Propeller Pumps

Model DSZ3

EBARA Pumps Americas Corporation

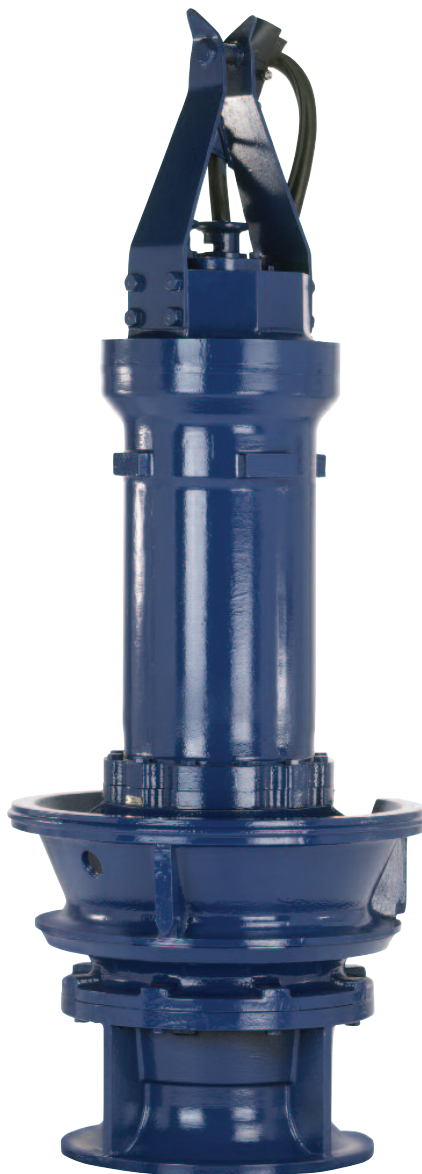
- **Watertight cable entry system** prevents capillary action and protects against moisture; reduces maintenance costs
- **Junction area** includes a terminal board for cable connections allowing for fast efficient replacement; area sealed from the stator housing; prevents leakage into the motor; reduces the possibility of failure

- **Heavy duty, high efficiency, air filled motor, Class F** insulated, rated for 311°F with a 1.10 service factor dissipates heat easily; thermal protection in each phase of windings protects; operates cooler with higher efficiencies; longer service life with lower operating costs

- **Double and triple row grease bearings** carries thrust loading with L-10 life of 100,000 hours; ensures long, dependable operation and lowers maintenance costs

- **Float type leakage detector** provides early warning of mechanical seal failure; avoids costly motor repairs
- **Cartridge type, duplex mechanical seals** assembled in tandem arrangement; easy maintenance and high reliability

- **High efficiency, axial flow impellers** accept large diameter solids; lowers operating costs
- **Replaceable case liner** maintains working clearances while lowering case replacement costs

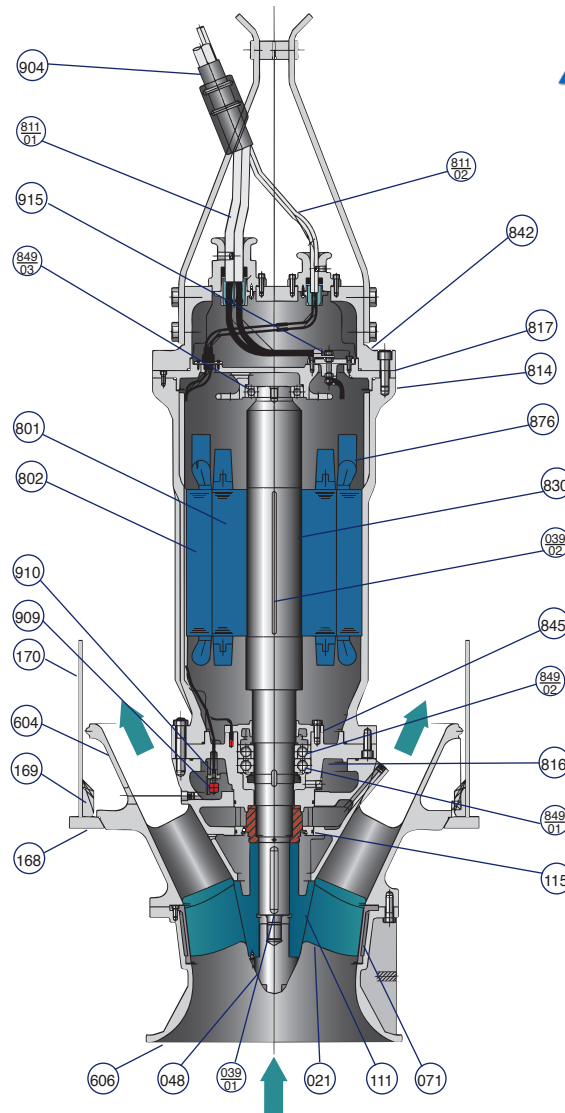
Double mechanical seal detail

- Upper seal O rings — NBR
- Upper seal faces — Carbon vs Ceramic
- Lower seal O rings — Viton
- Lower seal faces — Silicon carbide vs Silicon carbide
- Seal springs — 304SS
- Shaft sleeve — 304SS

Note: Optional seal face materials available

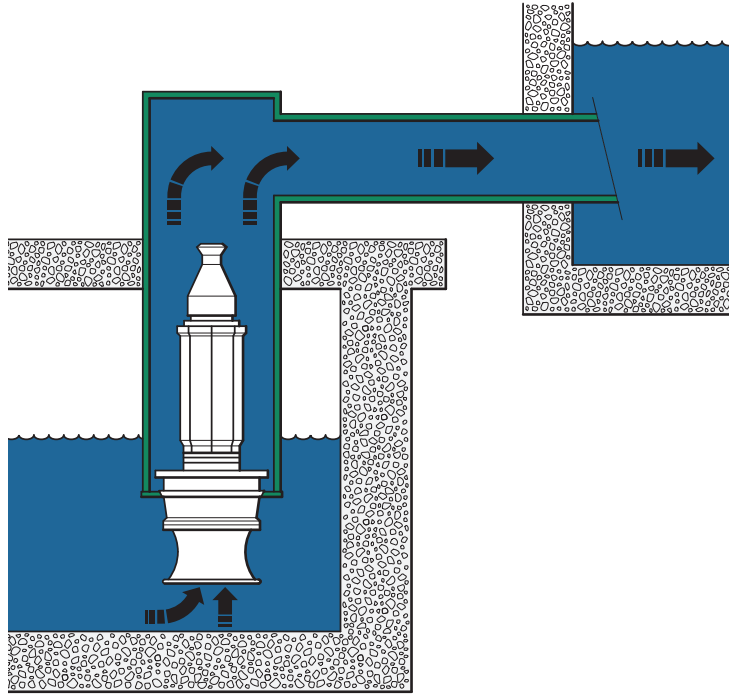
Vertical suspended column with horizontal discharge

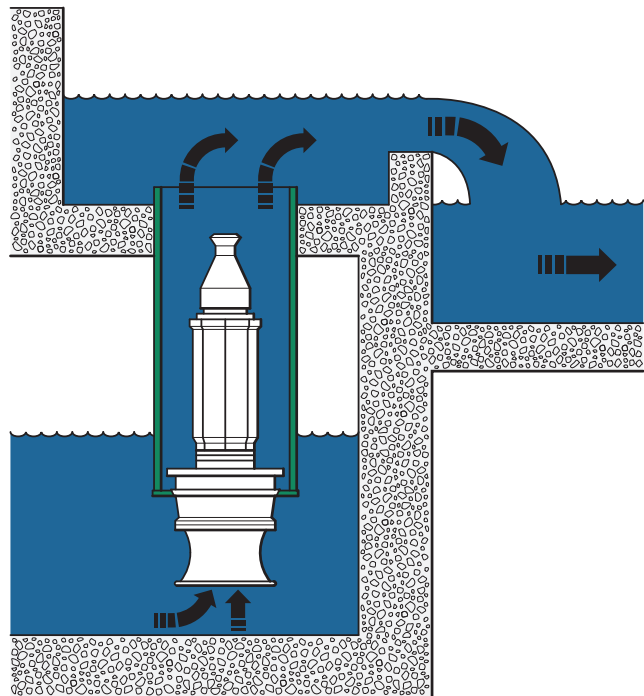
Vertical suspended column with vertical discharge
